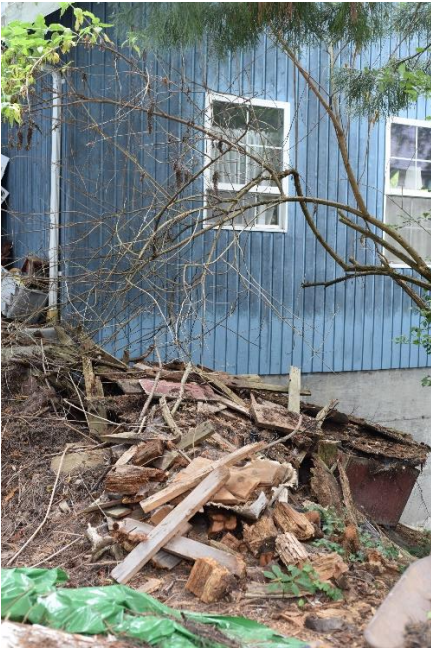
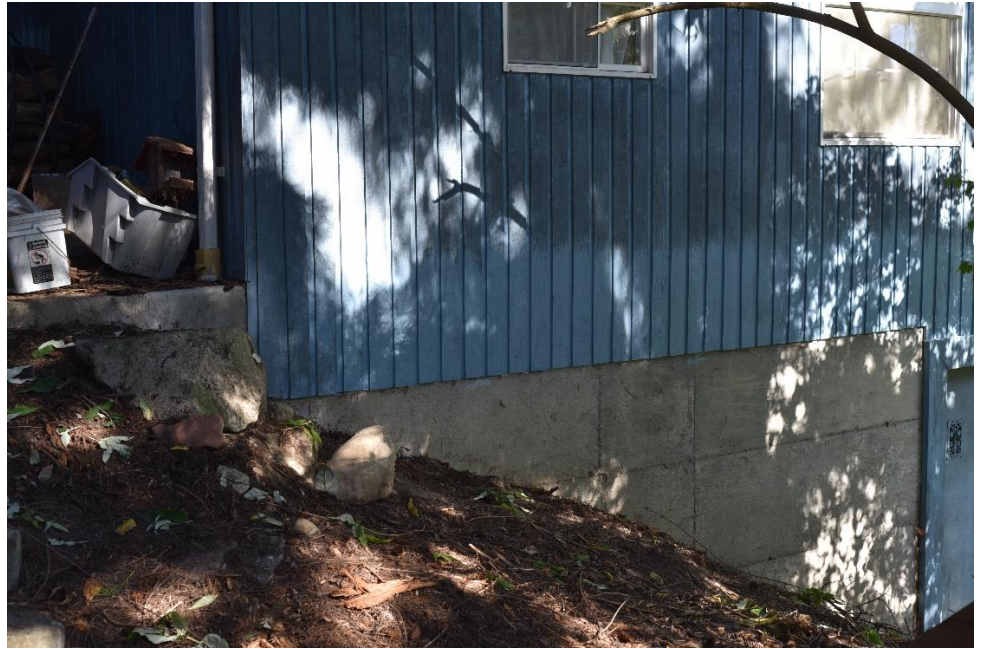
Scrap wood removed from northwest corner of the house. Bush trimmed away from house.

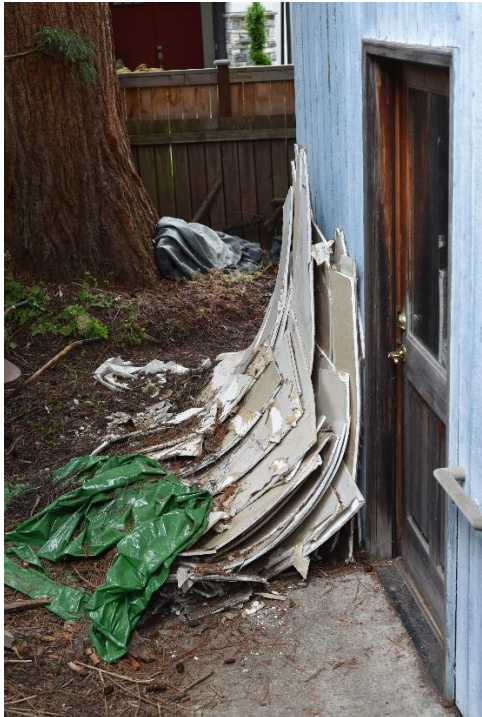
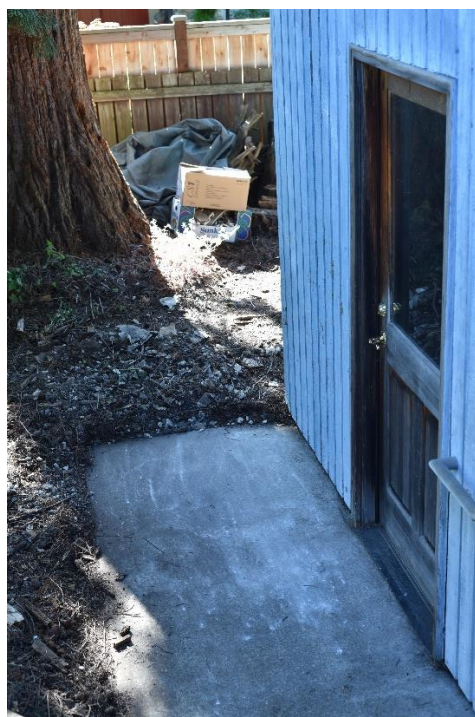
Construction debris from the southwest corner of the garage was sent to the transfer station.

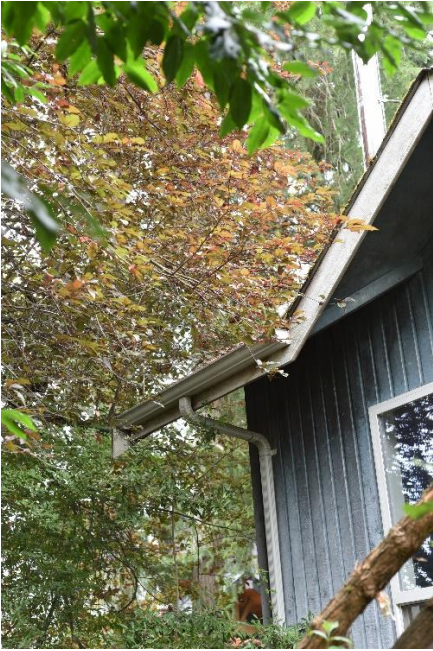
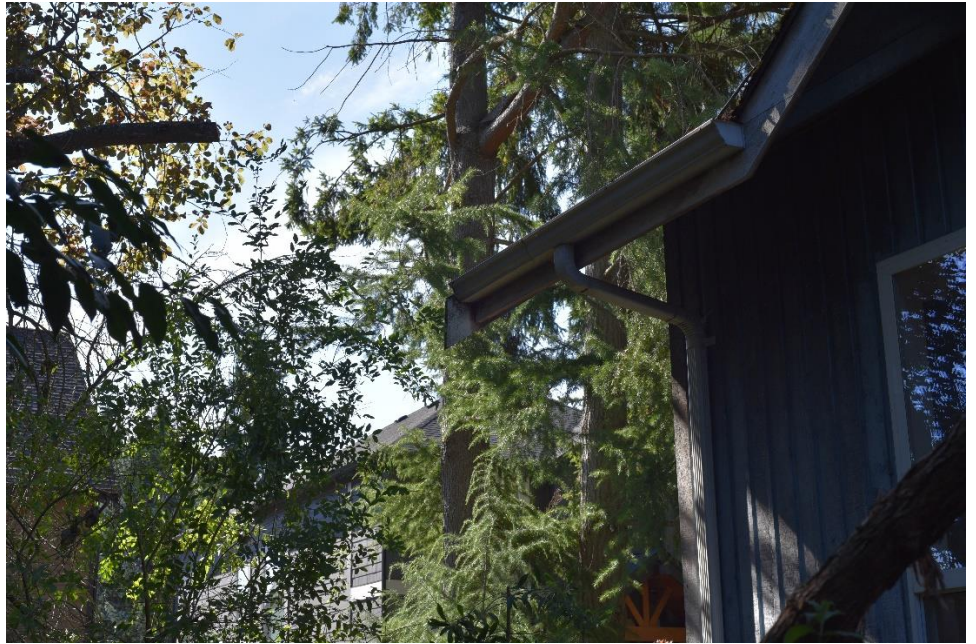
Plum tree branches growing over southwest corner of the house now cut well back.

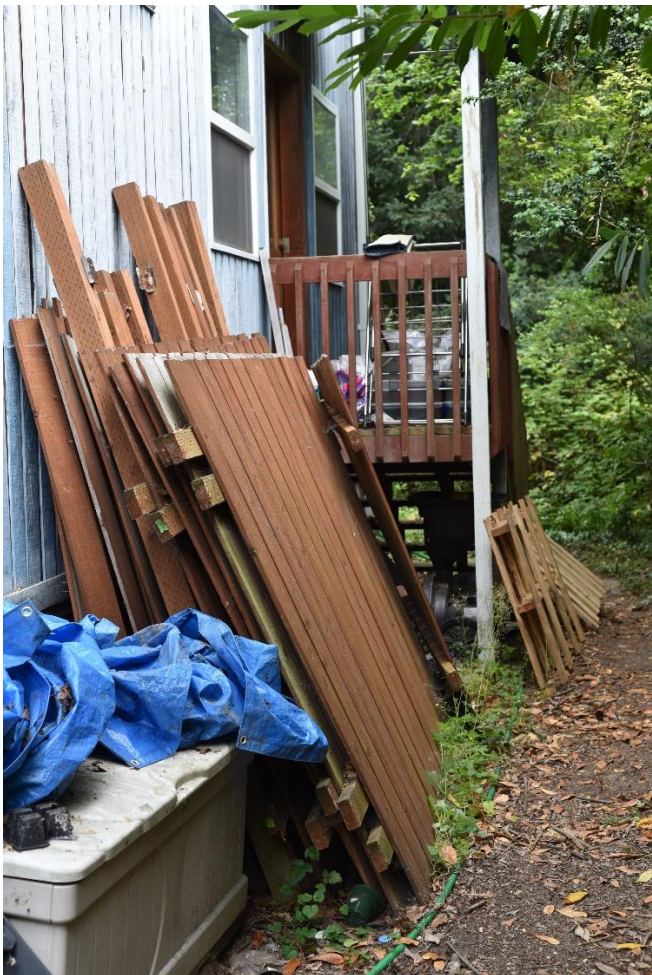
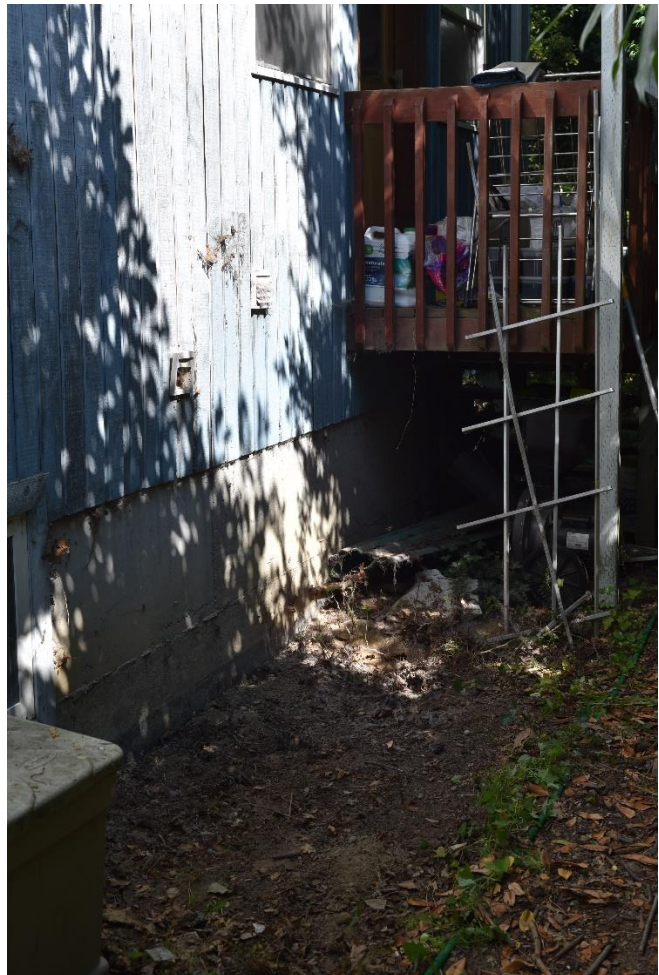
Cedar fencing removed from east side of house.
